TECHNICAL ADVICE

Reg.No 85488-07-016
Edition. 1

Market Area(s): All	Vehicle Model(s): 9-5
Subject: Too Hot Air in Rear Vents

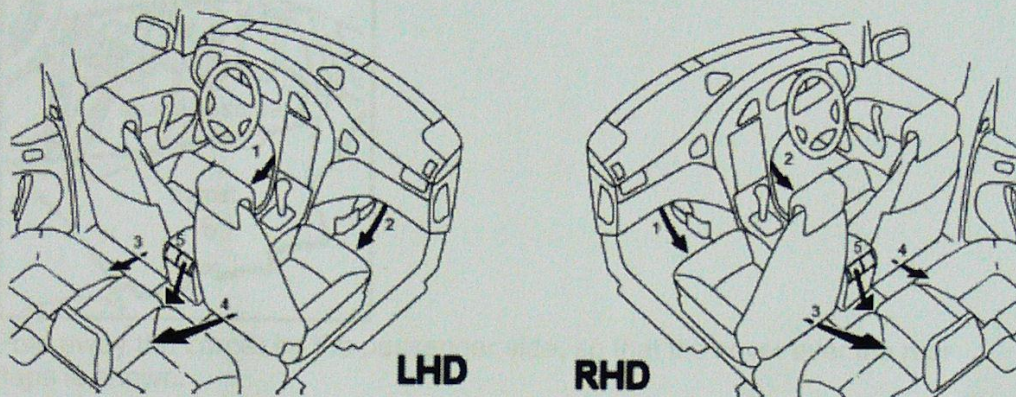
The front system is blowing a certain temperature out of the Front Floor Passenger Outlet (2 in LHD picture below, 1 in RHD picture below,). The air temperature from the Rear Air Outlets (3, 4 and 5 in pictures below) is at least 10 degrees higher.

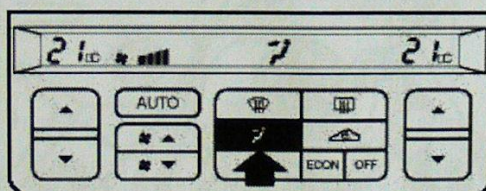
M98-M05

- 1 Ignition set in position ON.

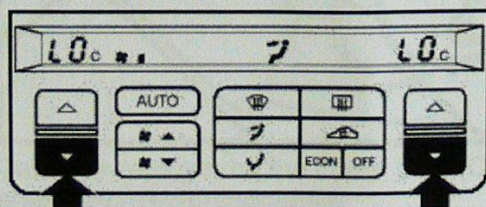
M98-M05

- 2 Set distribution mode in VENT.

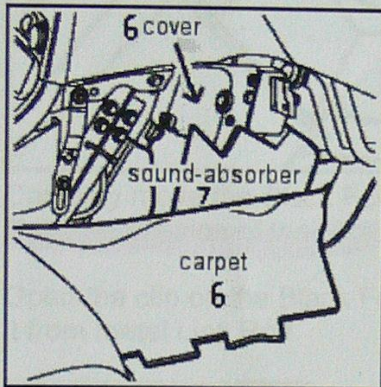
Following Pictures shows LHD vehicle, RHD is inverted.

Where parts are Yellow, they are for LHD vehicle, the same parts are Blue for RHD.

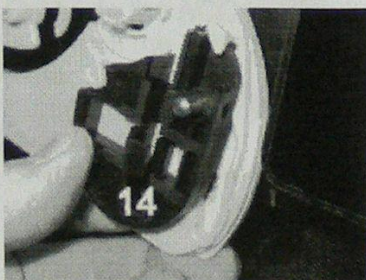
- 12 Move the semi circled heater flap plate (the one that is farthest in) to its upper end position. Keep this position with your finger.
- 13 Fit in the rear steel pin of the Black Follower into the oval hole in the semi circled heater flap plate.

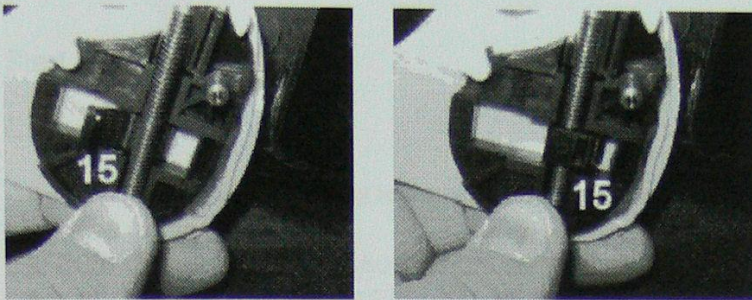
- 14 Press the Black Follower to its upper end position. Keep this position with your finger. Still keep the finger on semi circled heater flap plate.

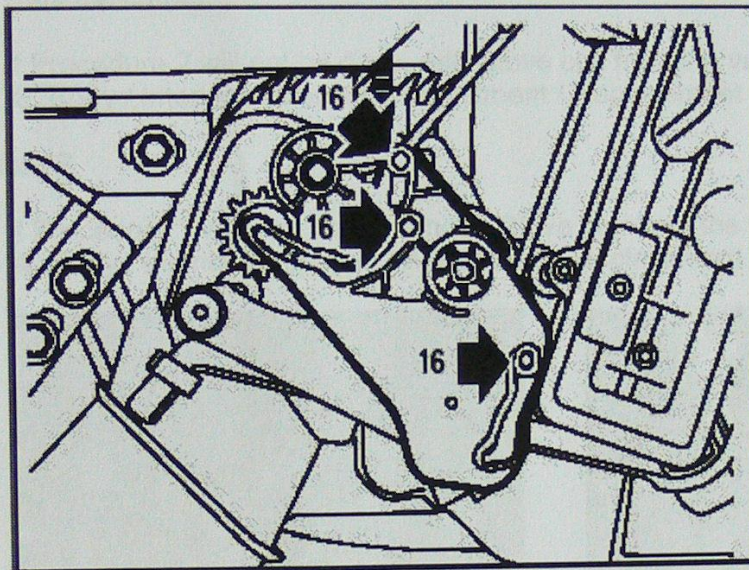
- 15 Press carefully the metal Link Rod upwards and into its position in the Black Follower, still keep the finger on semi circled heater flap plate. Secure the clip of the Black Follower.

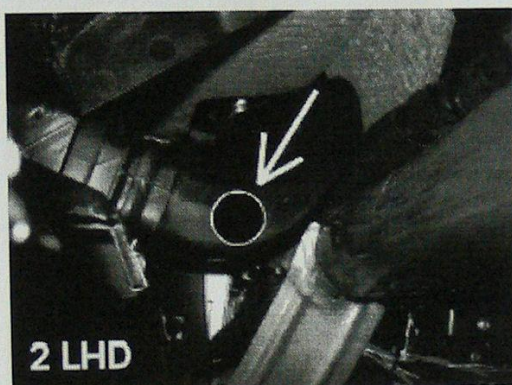
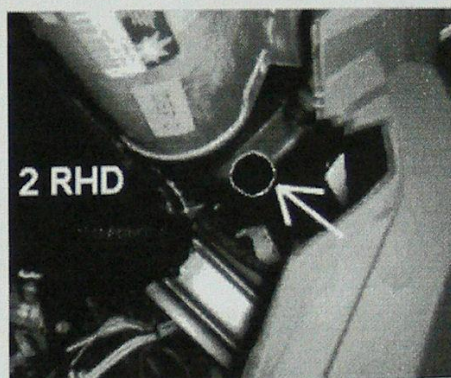
- 1 If Procedure 1 was not done, remove Glove box from the vehicle according to WIS 9-5-8. Body / Interior equipment / Adjustment / Replacement / Glove box.

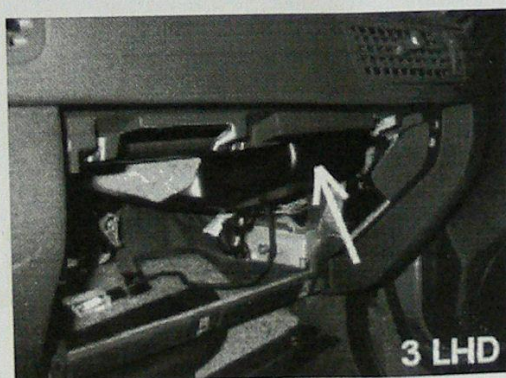
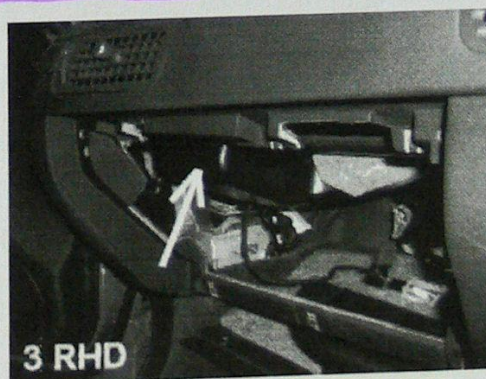
- 2 Locate the Passenger Centre Duct, leave the duct in position and drill a 27 mm diameter hole. Drill the hole on the radius, approximately 50 - 60 mm from the dashboard outlet. **Note**, it is very important that the holes are drilled to the specified size. Remove all loose plastic particles around the drilled holes.

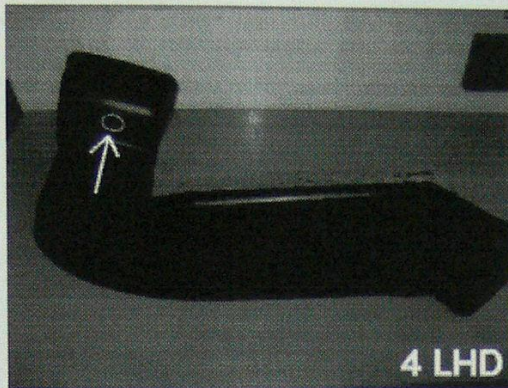
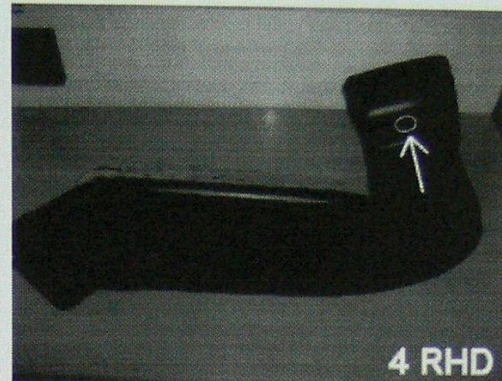
- 3 Locate the Outer Passenger Side Duct.

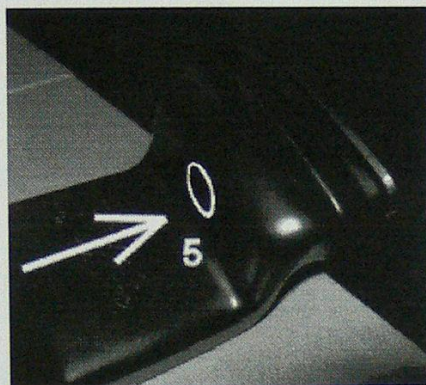
- 4 Remove the Outer Passenger Side Duct from the ventilation housing. and the outlet in the dashboard, take it out of the car and drill a 27 mm diameter hole.

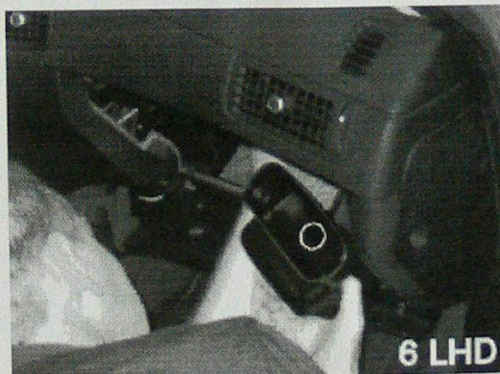
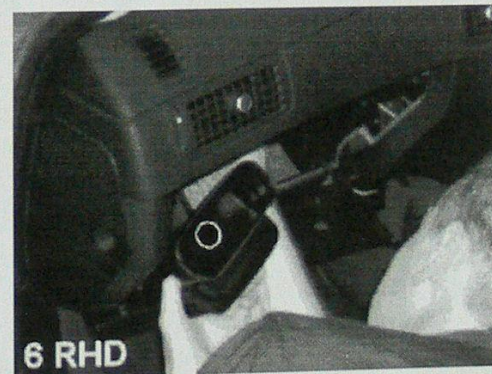
- 5 Drill the hole on the "back side" of the duct, just below the radius.
Note, it is very important that the holes are drilled to the specified size. Remove all loose plastic particles around the drilled holes.
